Manhole Inspection Summary

Manhole # S21KK1003MH

Insp Date: **11/20/06 9:18 AM**

Location Address: **4401 CLYDESDALE AVE**

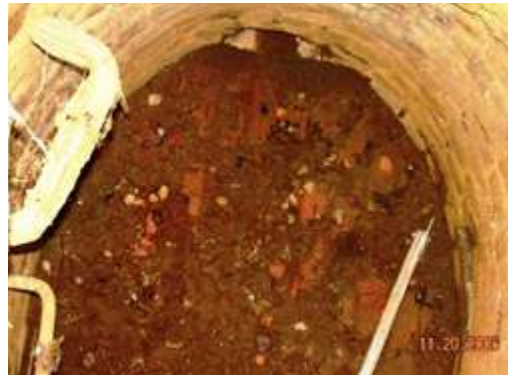
Top View

Infiltration: ☐ None ☐ Joint ☐ Cracks ☒ **Mortar** ☐ Roots ☒ **Wall**

☒ **Debris** (not Condition related)

Count: **3** Missing: **0** ☒ **Corroded**

Barrel infiltration. Corroded steps.
Channel debris.

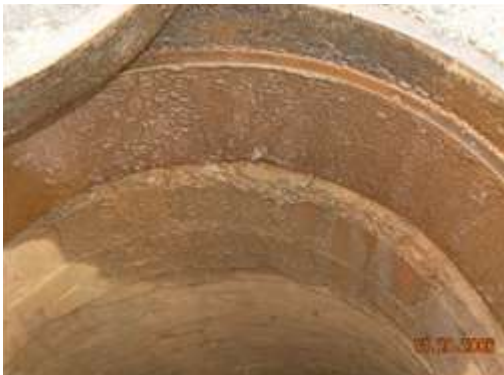
Defect

Offset: **0.5** (in.)

☒ **Leaks**

Condition: ☐ Sound ☐ Cracked ☐ Root Intrusion ☐ Loose Brick ☒ **Deteriorated**

Infiltration: ☐ None ☒ **Joint** ☐ Cracks ☒ **Mortar** ☐ Roots ☐ Wall

Frame leaks. Frame offset. Adjustment
deterioration and infiltration.

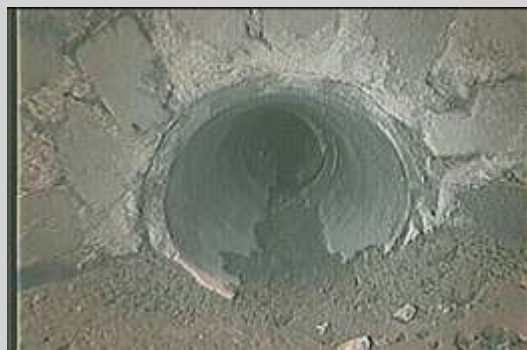
Pipe Out @ 12 O'Clock

Deposits: ☐ None ☒ **Mud** ☐ Sludge ☐ Debris ☐ Grease

Silt Depth: **0.5** (in.)

Deposits Extent: **Light**

Infiltration: **Evidence**
